Pavels GAVRILOVS*, Viktors IVANOVs

Riga Technical university, Institute of Railway Transport
Azenes street 12, LV-1048, Riga, Latvia

RESEARCH OF THE DEFECTIVE FROG WING OF 1/11 MARK

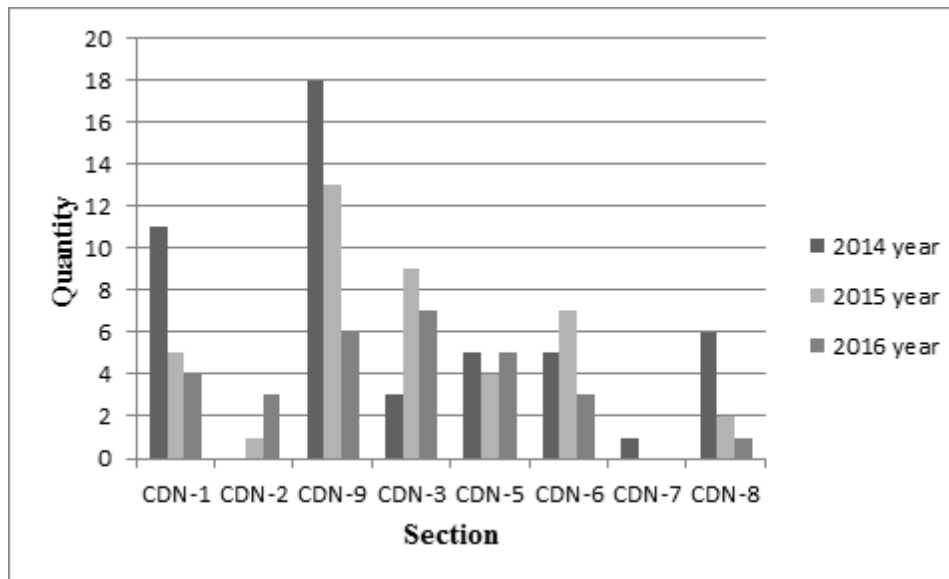
Fig. 1. Incidence of defective frog elements from 2014 to 2016

It follows from the diagram (Fig. 1) that, in 2014, the greatest number of rail defects was found in the CDN-9 Riga Department (18) and rail defects were not found in the CDN-2 Ciekurkalna Department. In 2015, 13 points defects were detected the Riga Department. Rail defects were not found in the CDN-7 Lepay Department for the whole year. In the previous year, 2016, the number of rail defects was reduced; in particular, only 7 rail defects were found in the CDN-3 Daugavpils Department. Rail defects were not found in the CDN-7 Lepay Department for the whole year.

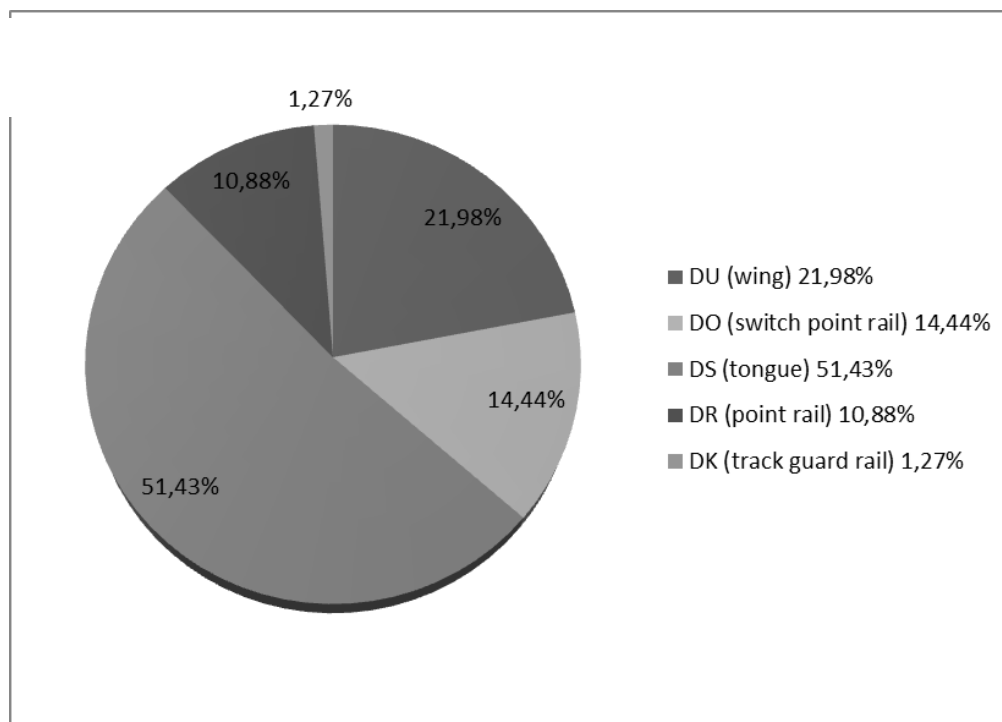
- Defects of the wing (21.98%);
- Defects of switch point rails (14.44%);
- Defects of the tongue (51.43%);
- Defects of the point rail (10.88%);
- Defects of the track guard rail (1.27%).

Fig. 4. Distribution of defects in point switches in the places of their formation in %

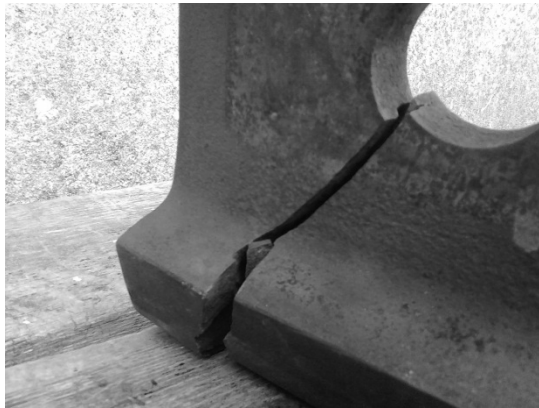
The defect code U.53. (Fig.5) is classified in the wing as cracks in the web from bolted or other holes in the rails and frog wings. Accordingly, the defect code U.53. is subdivided into the defect code U.53.1. and U.53.2., which means that U.53.1 is a defect of the wing in the joint and U.53.2 is a defect of the wing located outside the joint. Head chocks (small cracks) at the edges of the holes caused by drilling and corrosion accelerate the formation of a crack. The unsatisfactory condition of joints (weakening of bolts, subsidence in joints, the presence of large gaps) may be the main reason for the appearance and development of this type of defect [13].

Fig. 5. The cut specimen of the wing under the defect code U.53.2

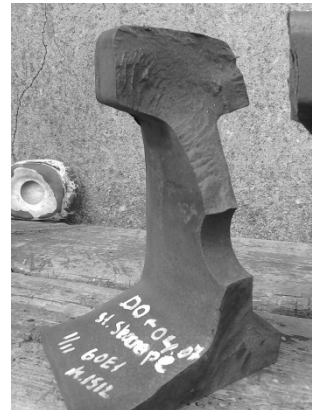
The aim of this research was to study the broken defective frog wing of the 1/11 mark with the defect code U.53.2., type of the frog 60 E1 DO 04 07, rail type UIC 60, produced by Dowlais Steel Works [6] in April 2007. This specimen of the wing of the third bolted hole (Fig. 6) was broken from the frog throat to the entry points No. 1 of the Sece station of the Latvian Railway.

Fig. 6. The part of the cut broken wing (end view)

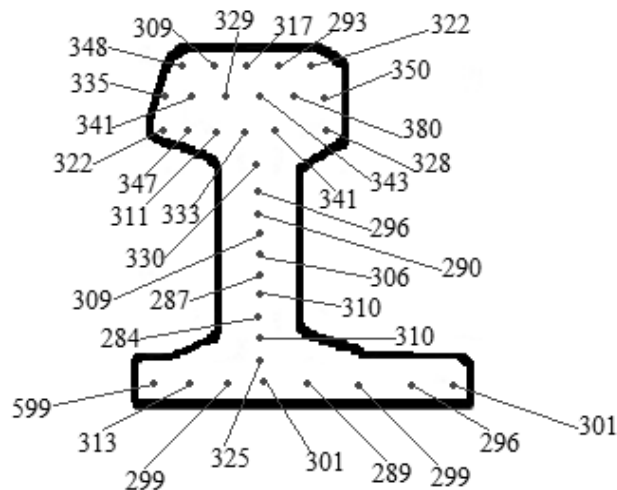
Fig. 7. Determination of hardness of the frog wing of the 1/11 mark with frog type 60 E1 DO 04 07 in HB:
at the wing top: 348, 309, 317, 293, 322, 335, 341, 329, 343, 380, 350, 322, 347, 311, 333, 341, 328.
in the wing web: 330, 296, 290, 309, 306, 287, 310, 284, 310, 325.
at the wing base: 599, 313, 299, 301, 289, 299, 296, 301.

The average hardness in the wing top was 322 HB, which is 47 HB less than the permissible value of the manufacturer [8]. During testing, the medium hardness in the wing web was 305 HB, which is 73 HB less. Based on the results obtained, the average hardness in the base was 337 HB, which is 51 HB less than the specifications of the Austrian manufacturer [10].

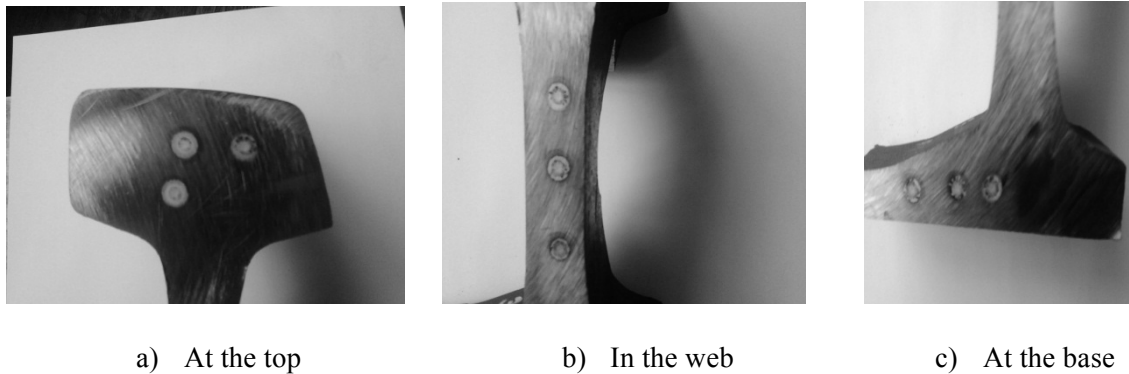
Fig. 8. Determination of the chemical composition in the three elements of the wing

On comparing the basic, permissible values of chemical elements of the composition of rail steel, the following conclusion can be drawn: the carbon (C) content is greater by 0.089% than the manufacturer's specification.

The results of the researches showed that the content of (Mn) manganese was normal. The chemical element silicon (Si) was in the permissible percentage ratio. The chromium (Cr) content was higher than the established value, with a standard value of 0.0129%. The percentages of chemical elements such as phosphorus (P) and (S) sulfur were not within the allowable limits. The percentage of phosphorus (P) was more at 0.067% and the percentage of sulfur (S) was more than 0.0186%. The percentage value of such chemical elements as nitrogen (N) was not determined during the researches. The content of aluminum (Al) had increased by 0.0003% [5].

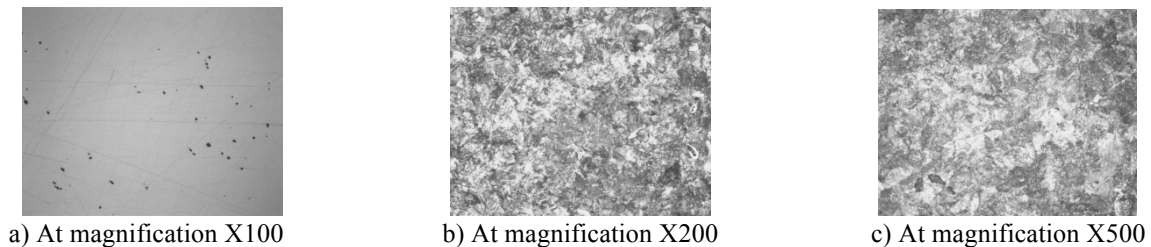
The obtained researches are shown in Fig. 10. As can be seen from Figure 10 (a), inclusions in the form of black spots were found in the metal structure. It can be assumed that the cause of the fracture was the presence of many inclusions in the metal because these inclusions could be a “nucleus” of the formation of cracks.

The metal structure was ferrite–pearlite. The ferrite–pearlite structure is a mixture of ferrite and cementite.

Fig. 9. Determination of the metal structure under a microscope at different magnifications

6. Analyzing the metal of the frog wing of the 1/11 mark, a large inclusion was found, which indicates the low quality of the metal.
7. From the above researches it is possible to draw the following conclusion: the possible reason for a fracture of the defective frog wing of the 1/11 mark involved a number of factors, namely, the discrepancy of the metal hardness, the predominance in the metal of harmful chemical elements such as sulfur (S) and phosphorus (P), as well as the presence of many inclusions.
